BARCELONA CITY CENTER EVOLUTION

STRUCTURAL DEFINITION

STRUCTURE BEFORE AND AFTER THE REFORMS

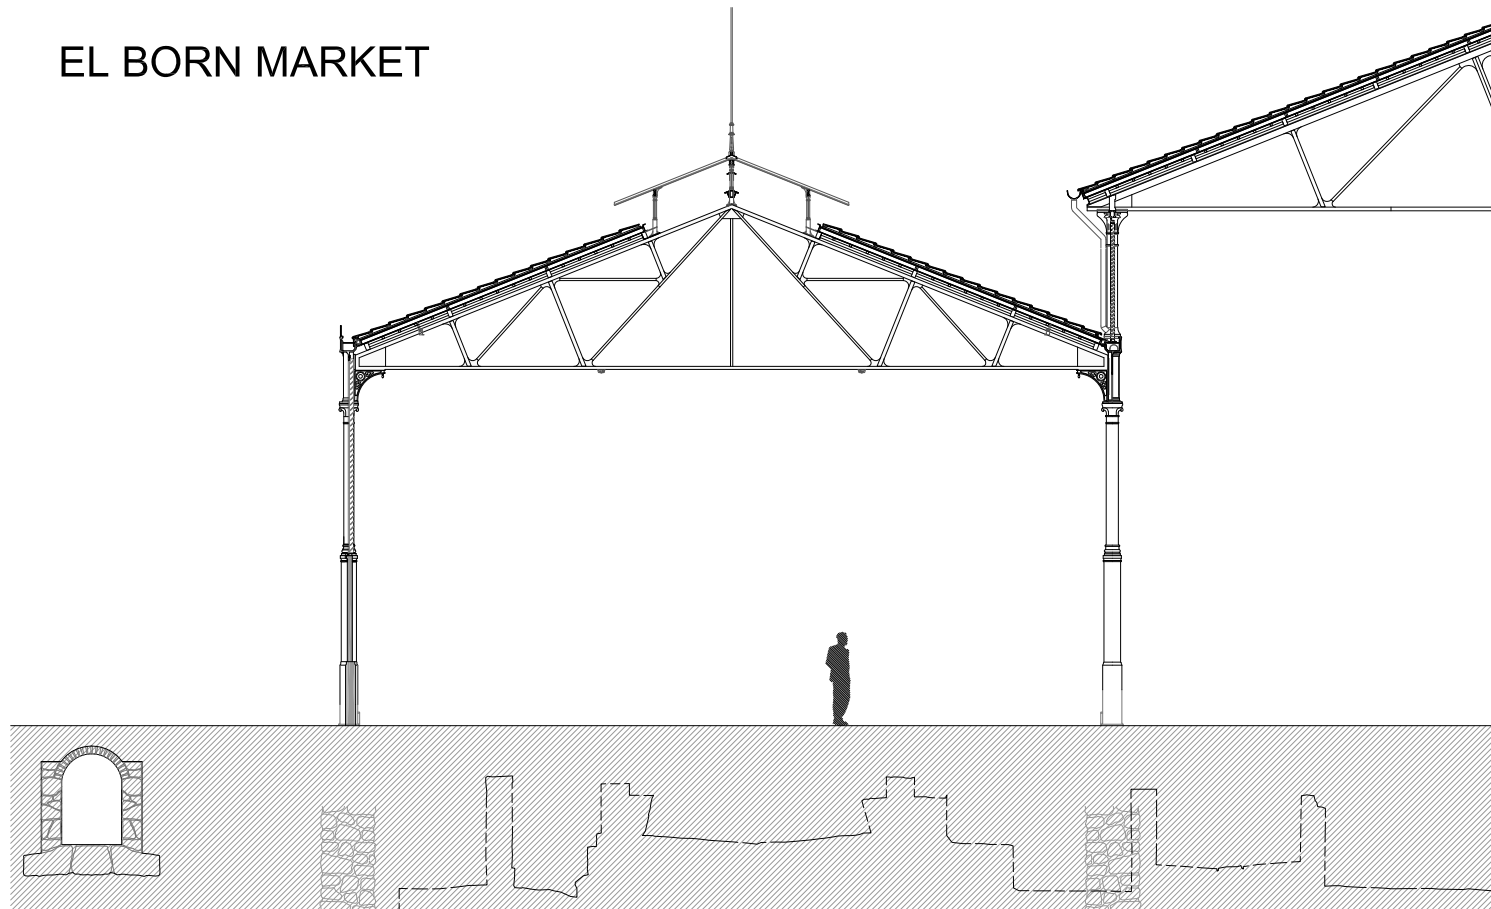
ORIGINAL SECTION, 1875

EL BORN MARKET

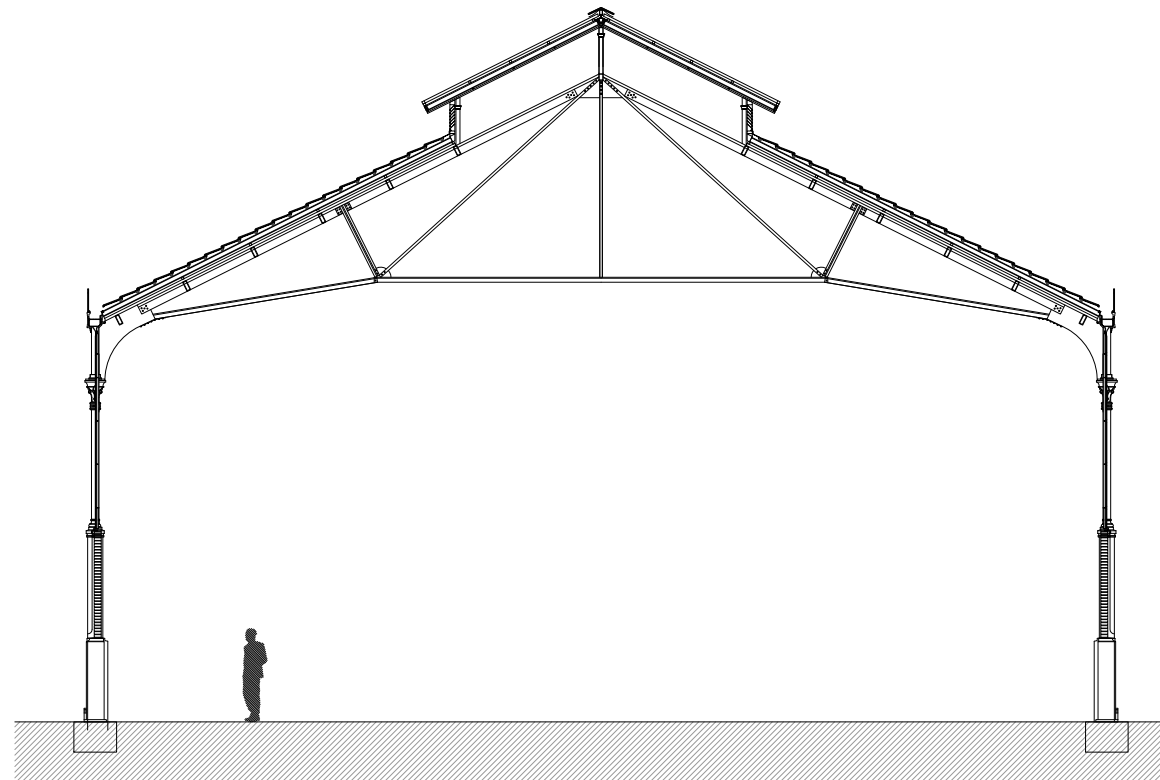
ORIGINAL SECTION, 1882

SANT ANTONI MARKET

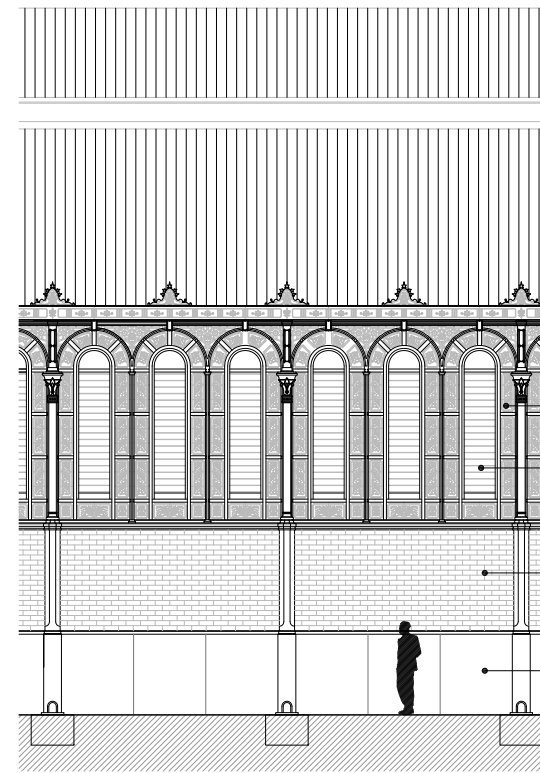
ORIGINAL FAÇADE 1882

- Ceramics
- Wood slats
- Brick
- Stone plinth

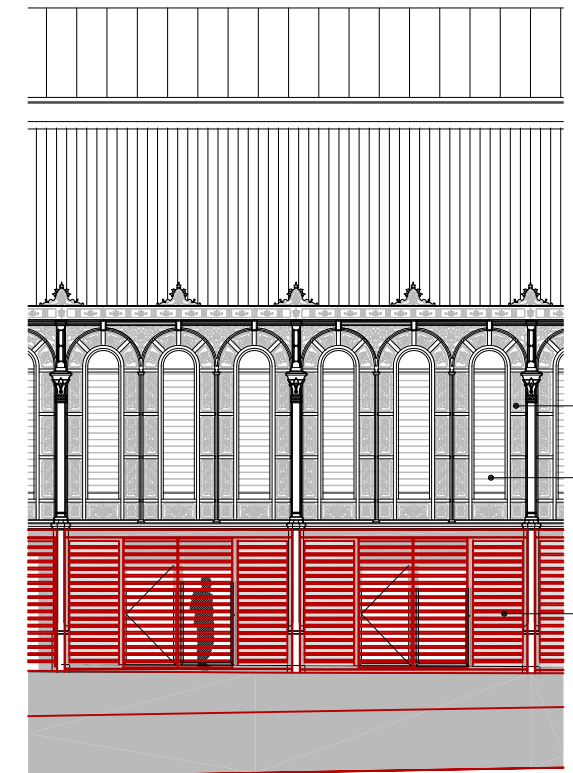
CURRENT FAÇADE, 2017

- Restored original ceramics
- Metal slats
- Metal slats enclosure

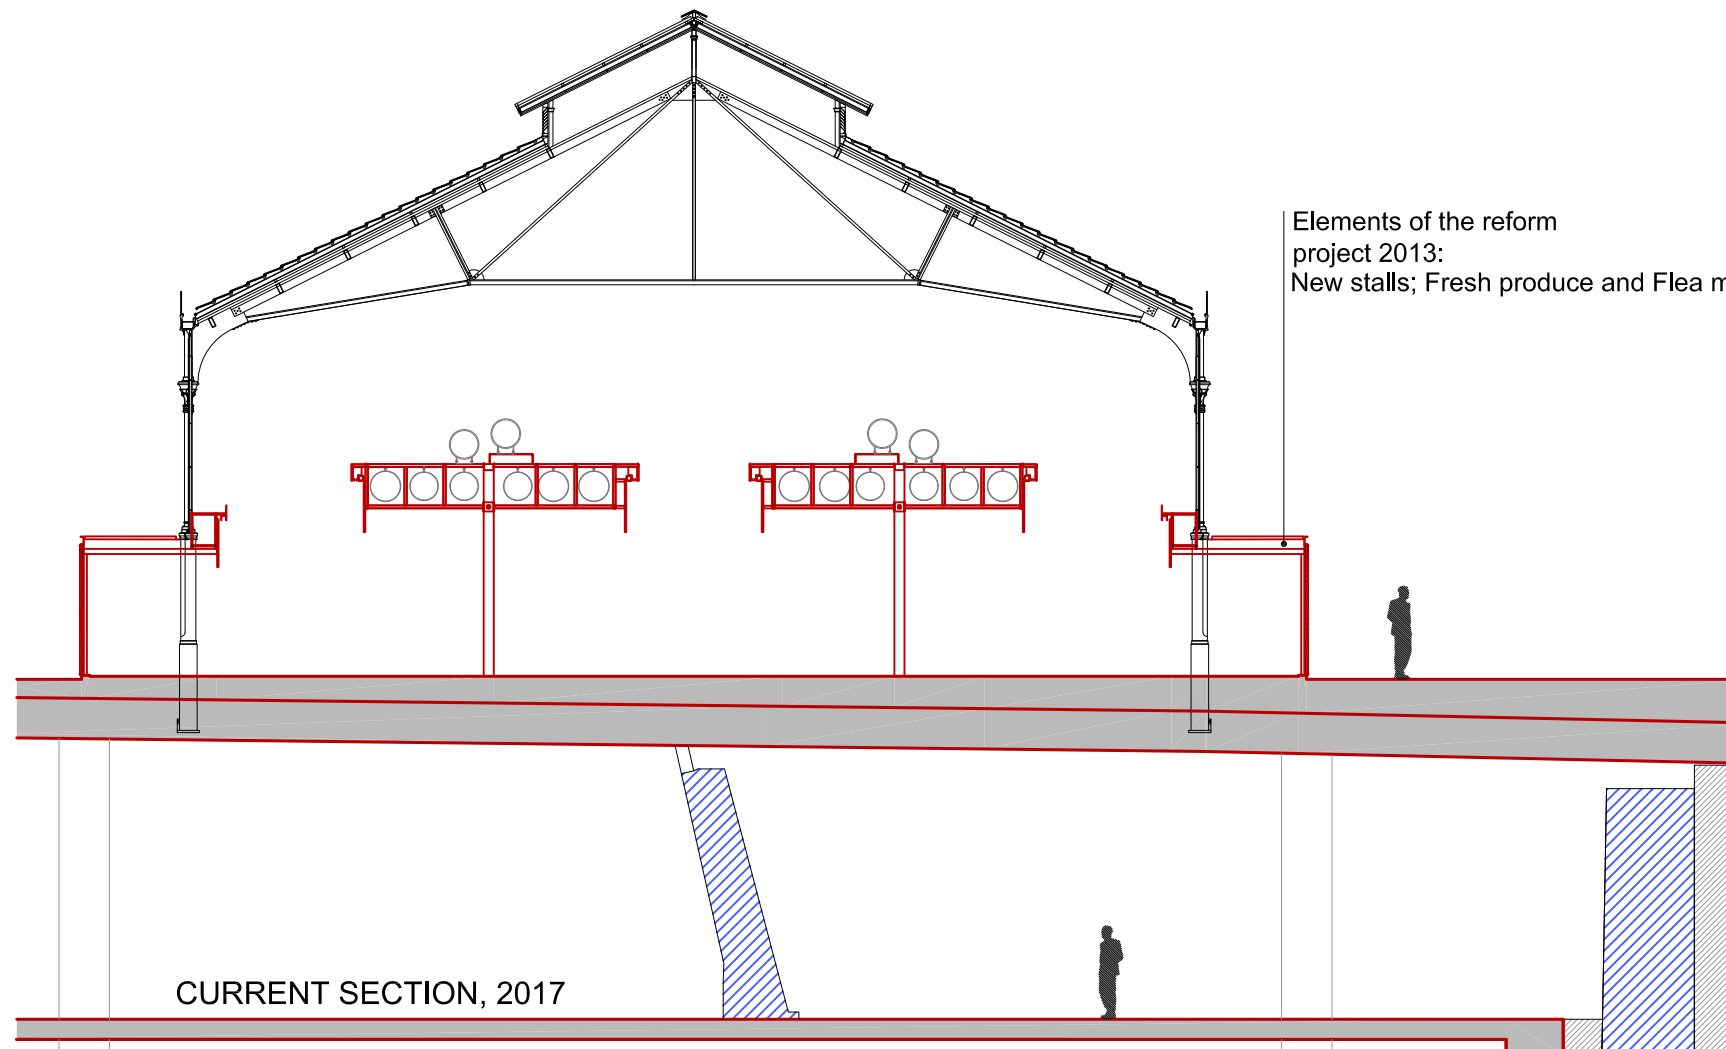
CURRENT SECTION, 2017

Elements of the reform project 2013:
New stalls; Fresh produce and Flea market

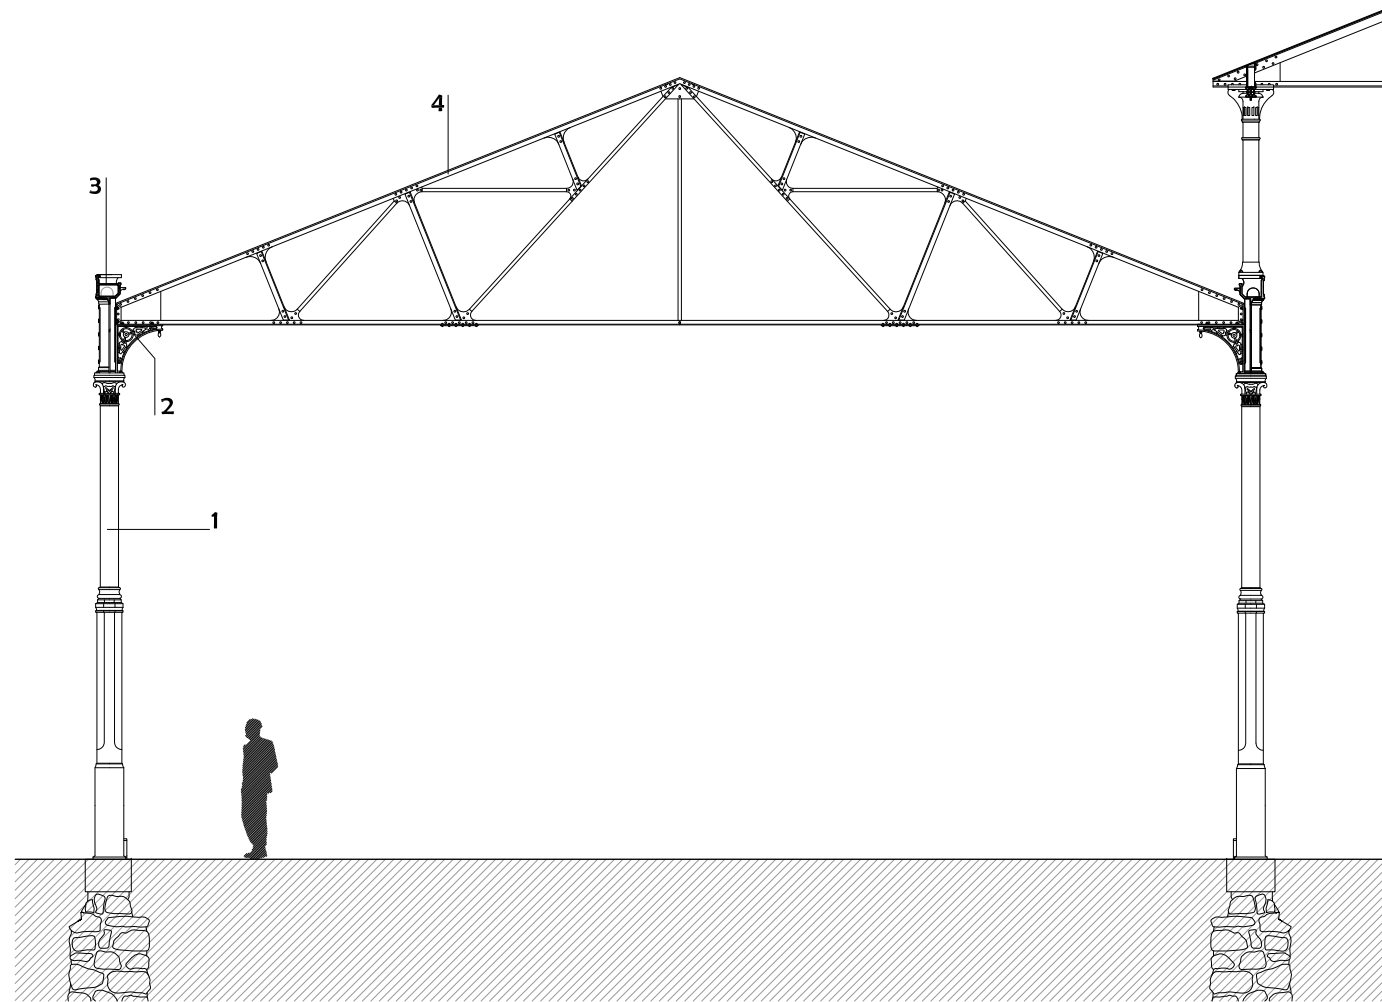
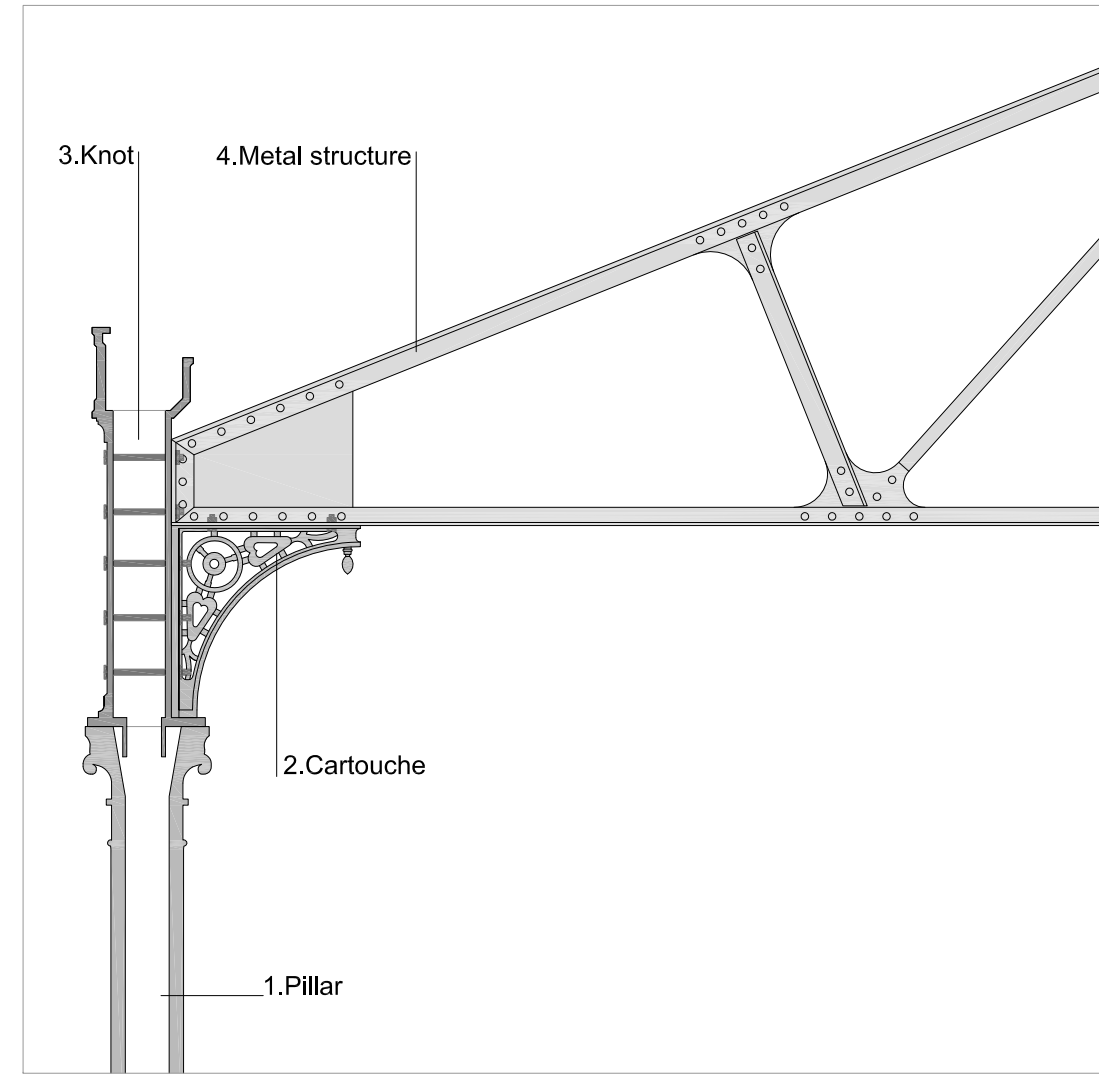
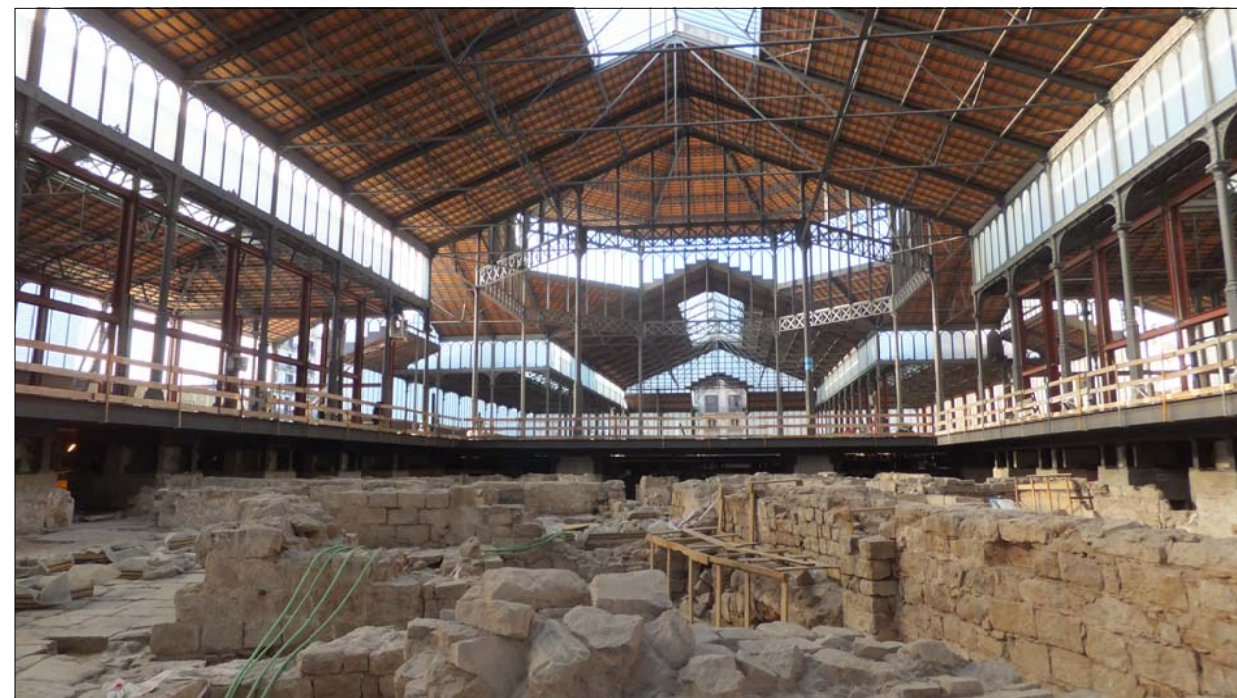
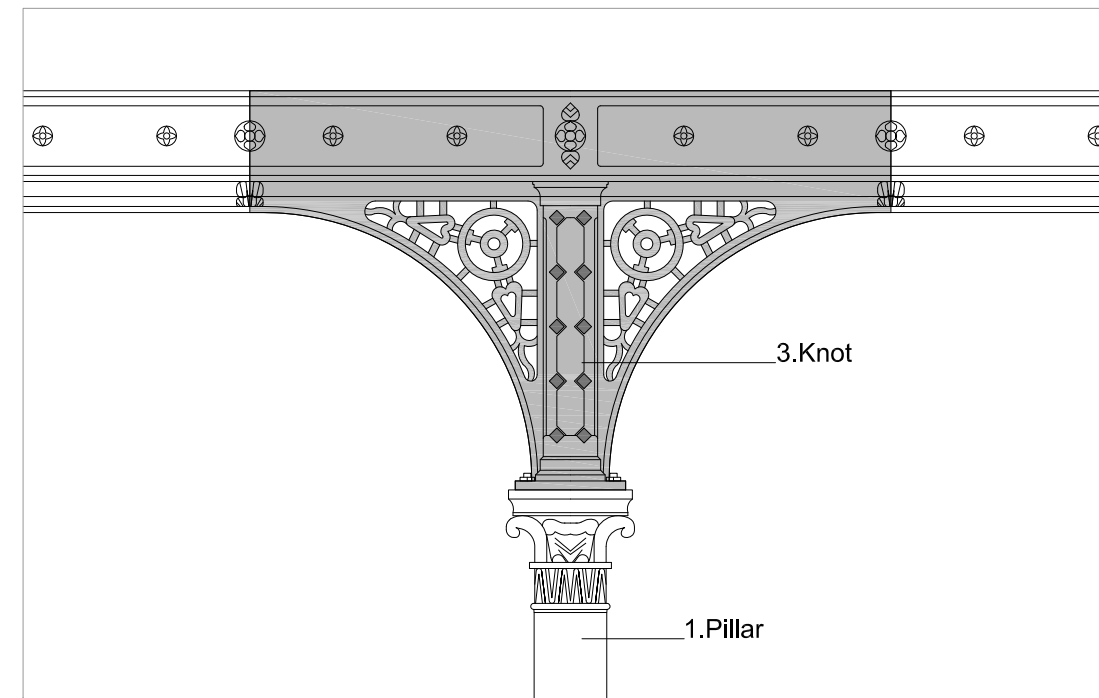
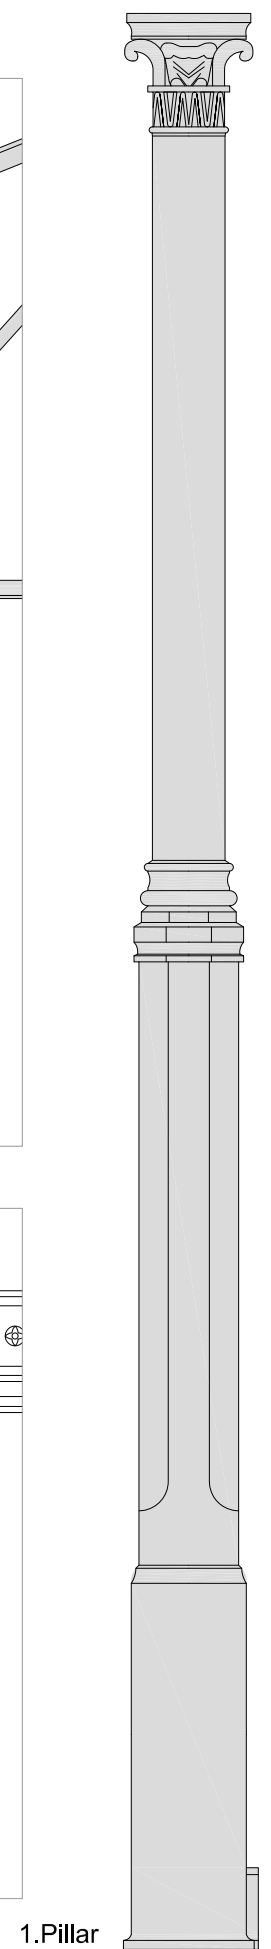
BASIC STRUCTURAL ELEMENTS

EL BORN MARKET

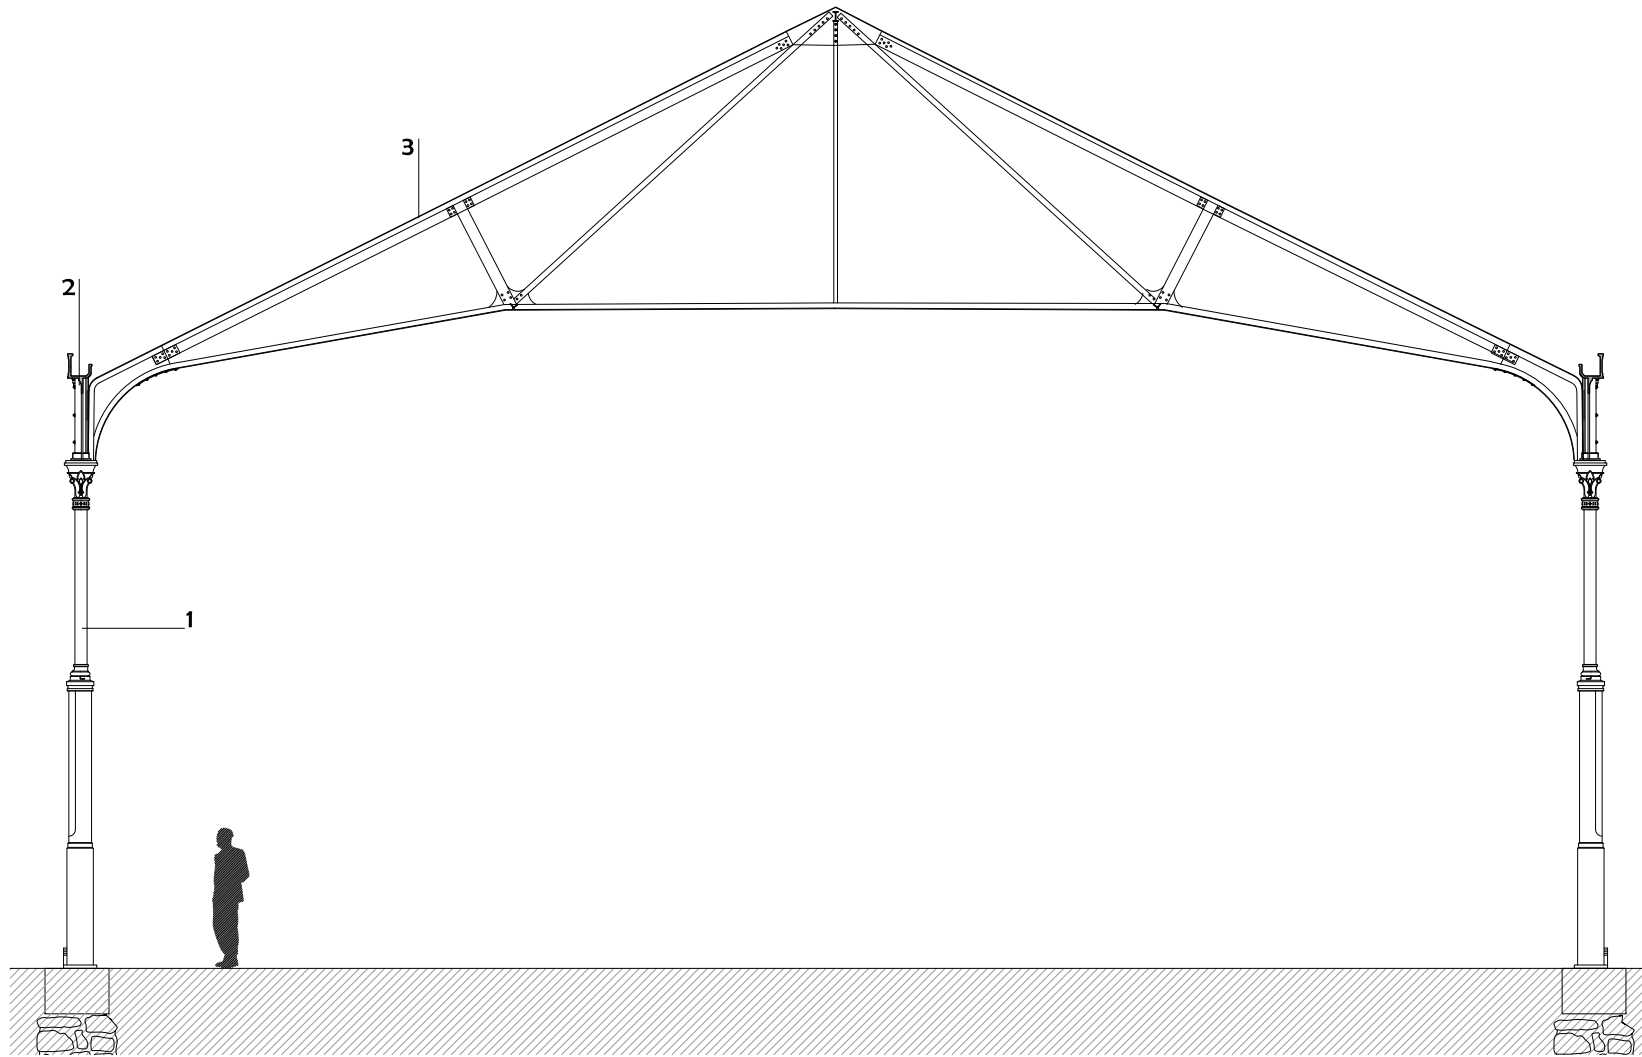
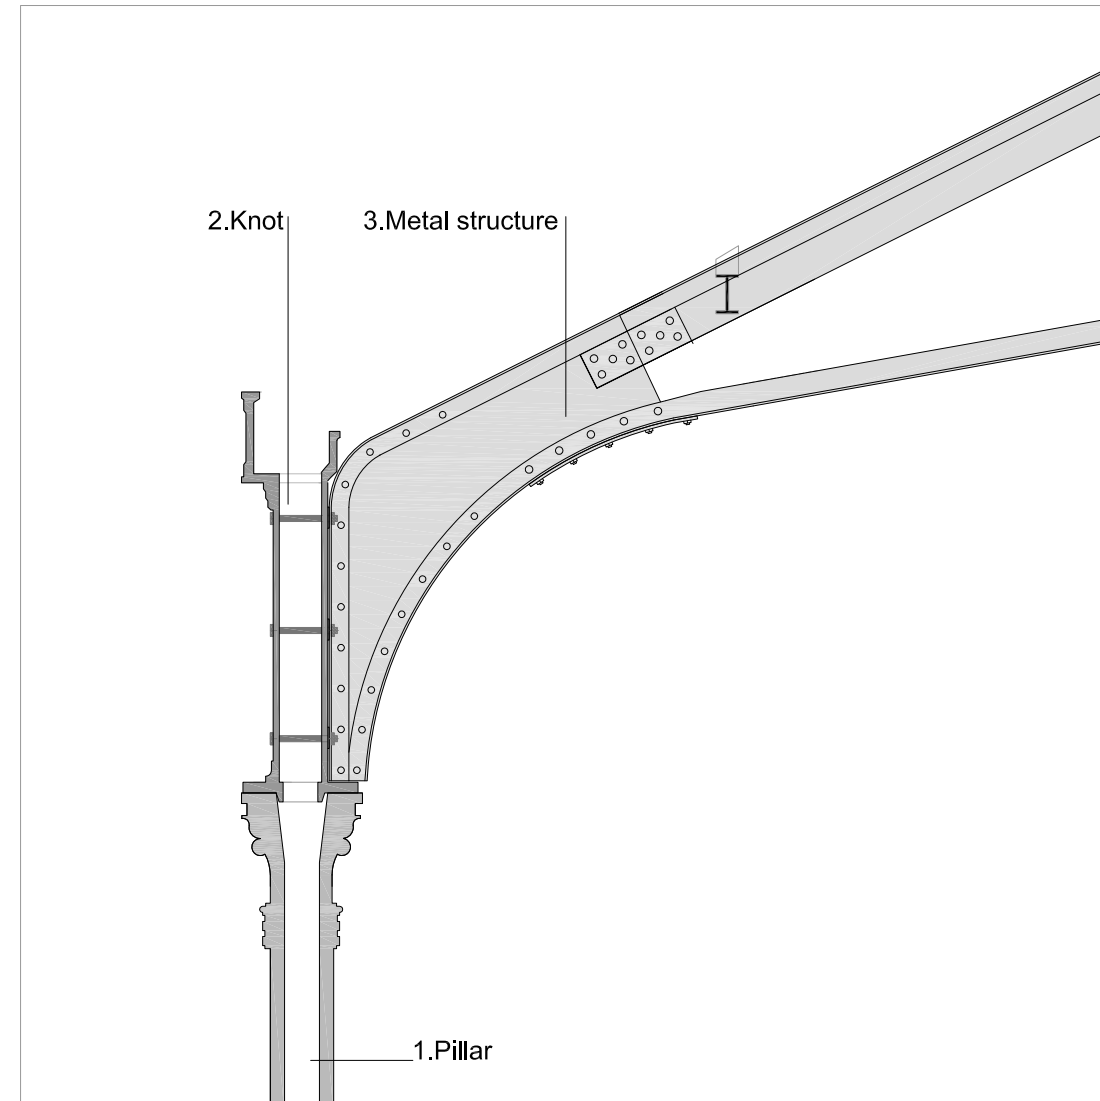
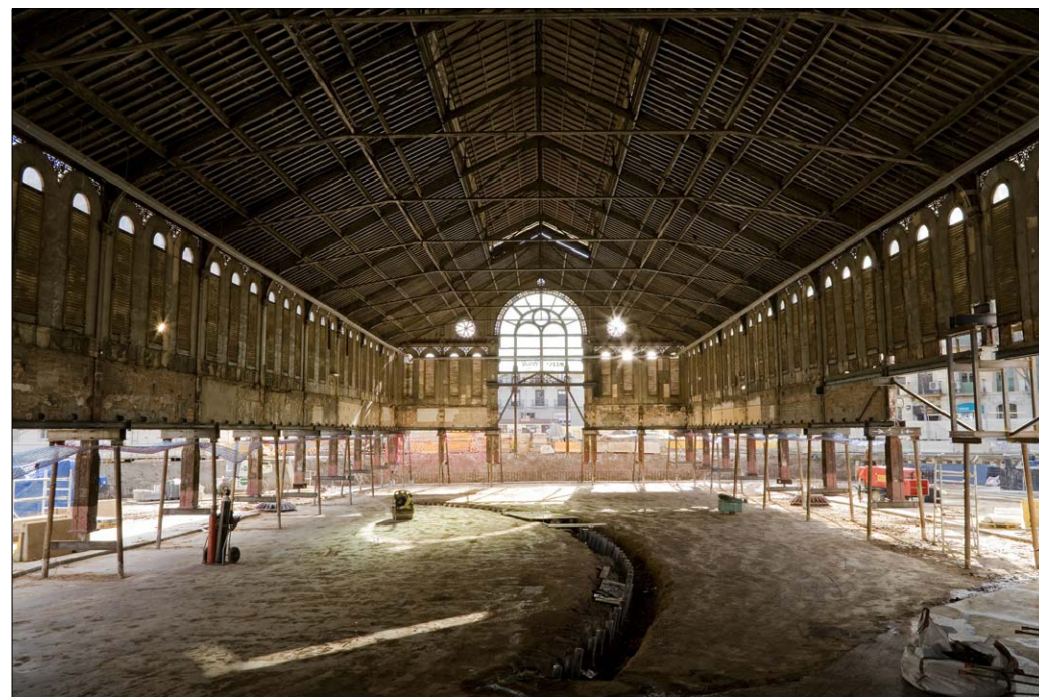
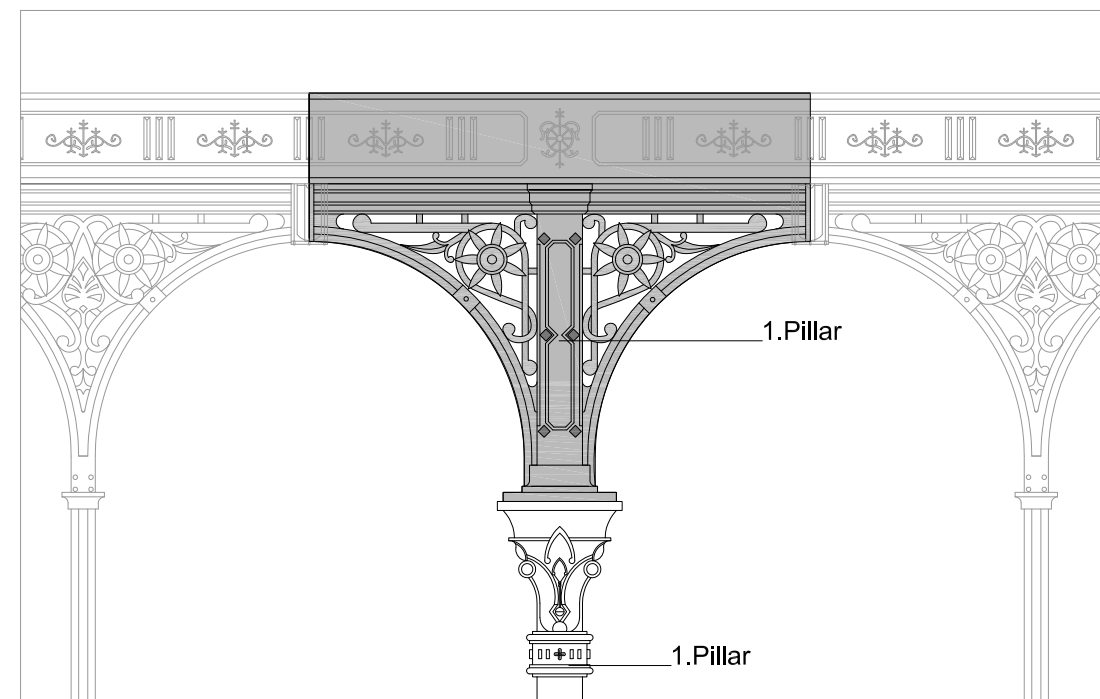
BASIC STRUCTURAL ELEMENTS

SANT ANTONI MARKET

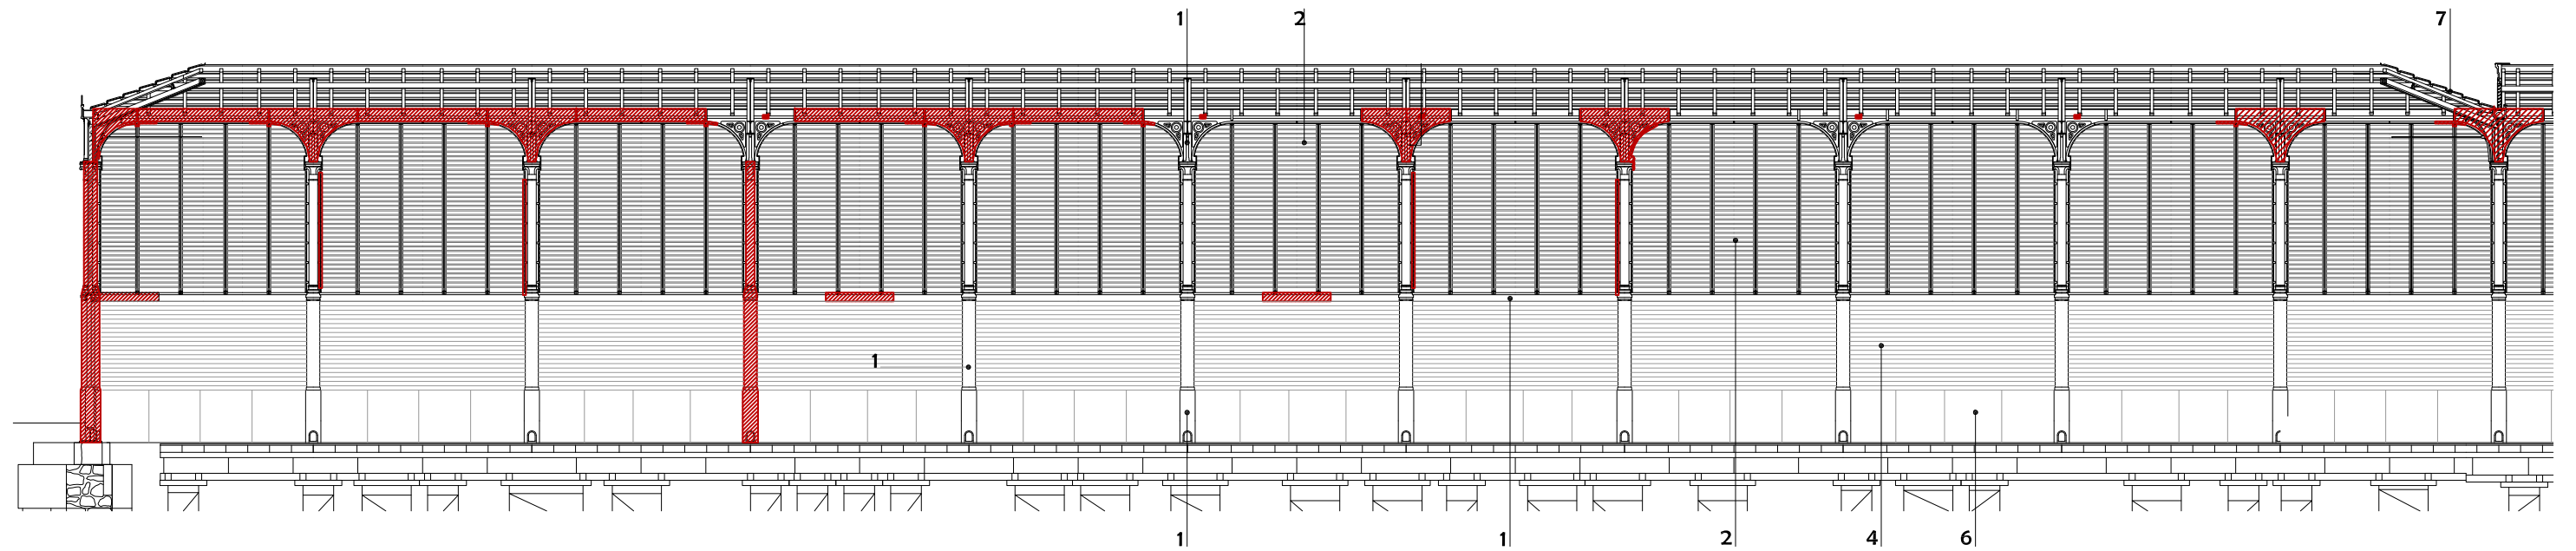
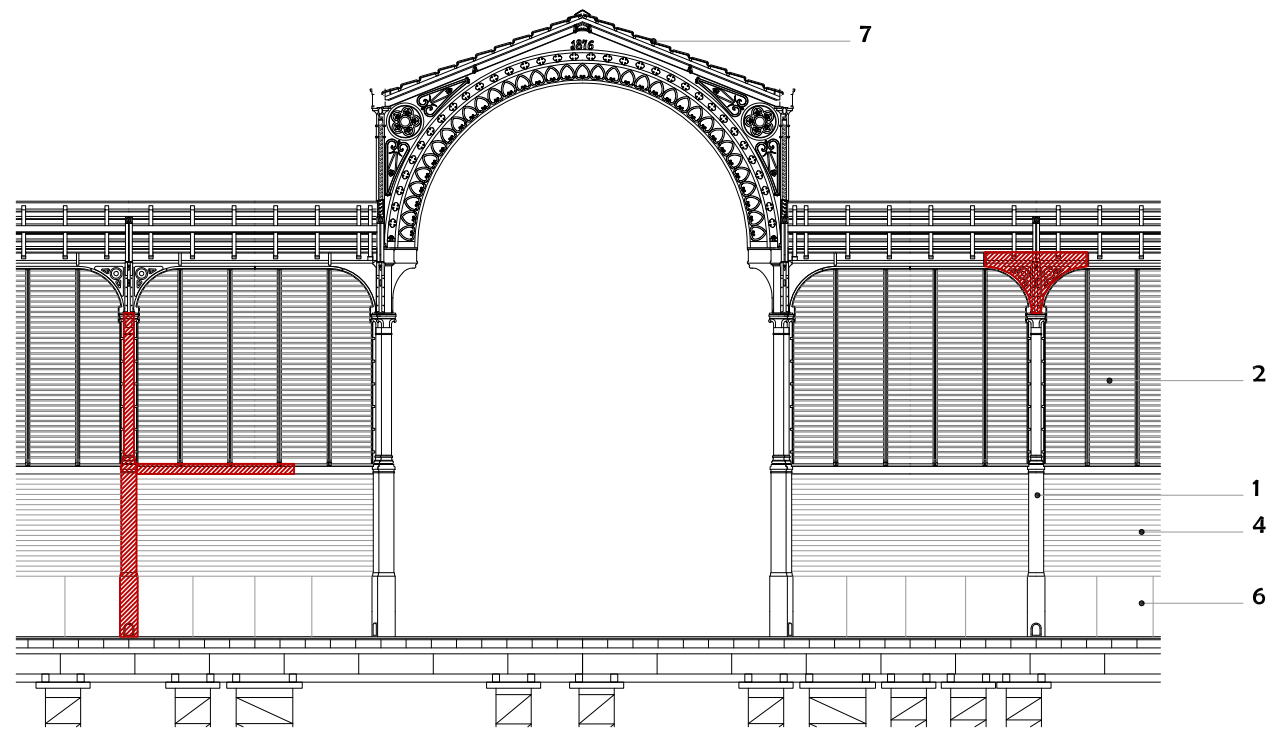
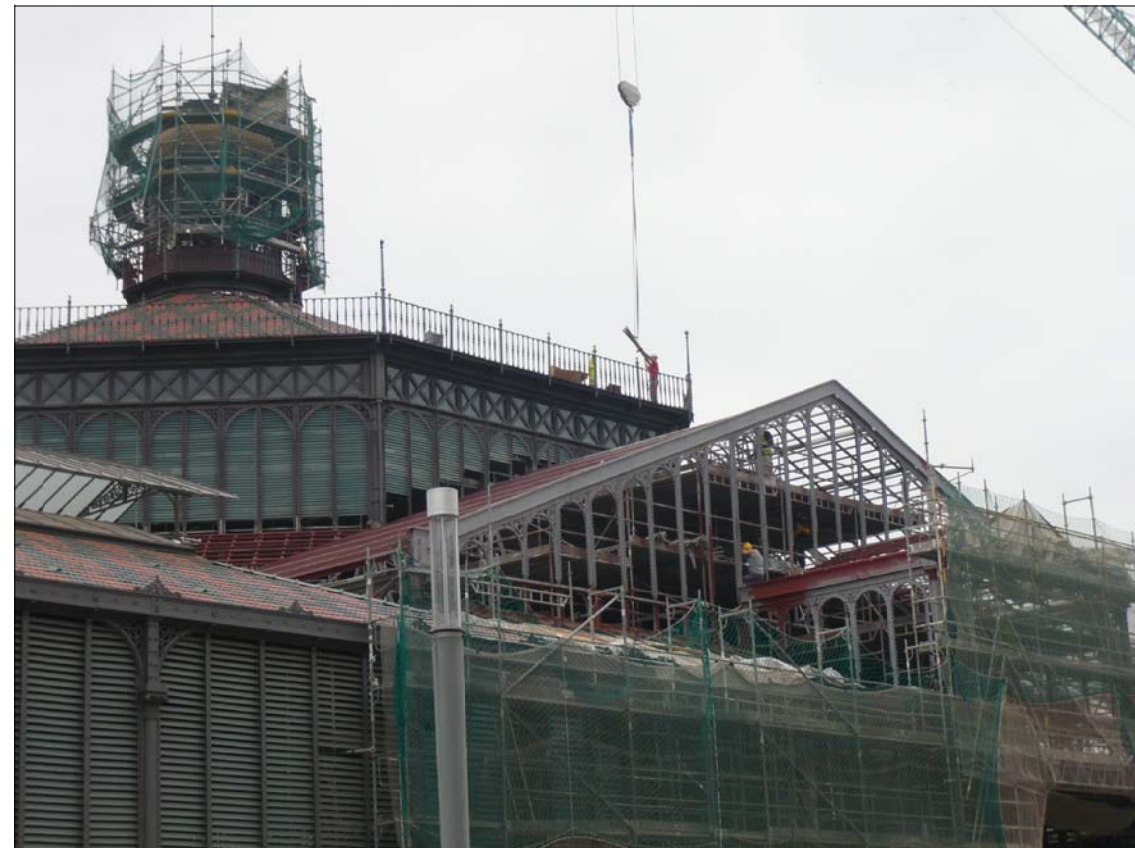
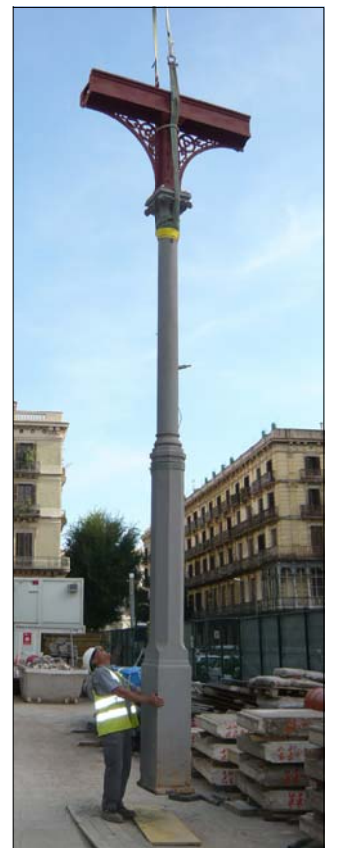
RESTORATION

Replaced elements

RESTORED ELEMENTS

1. Iron - Main structure
2. Enclosure - Glass slats
3. Enclosure - Metal slats
4. Brick
5. Ceramics
6. Stone
7. Tile

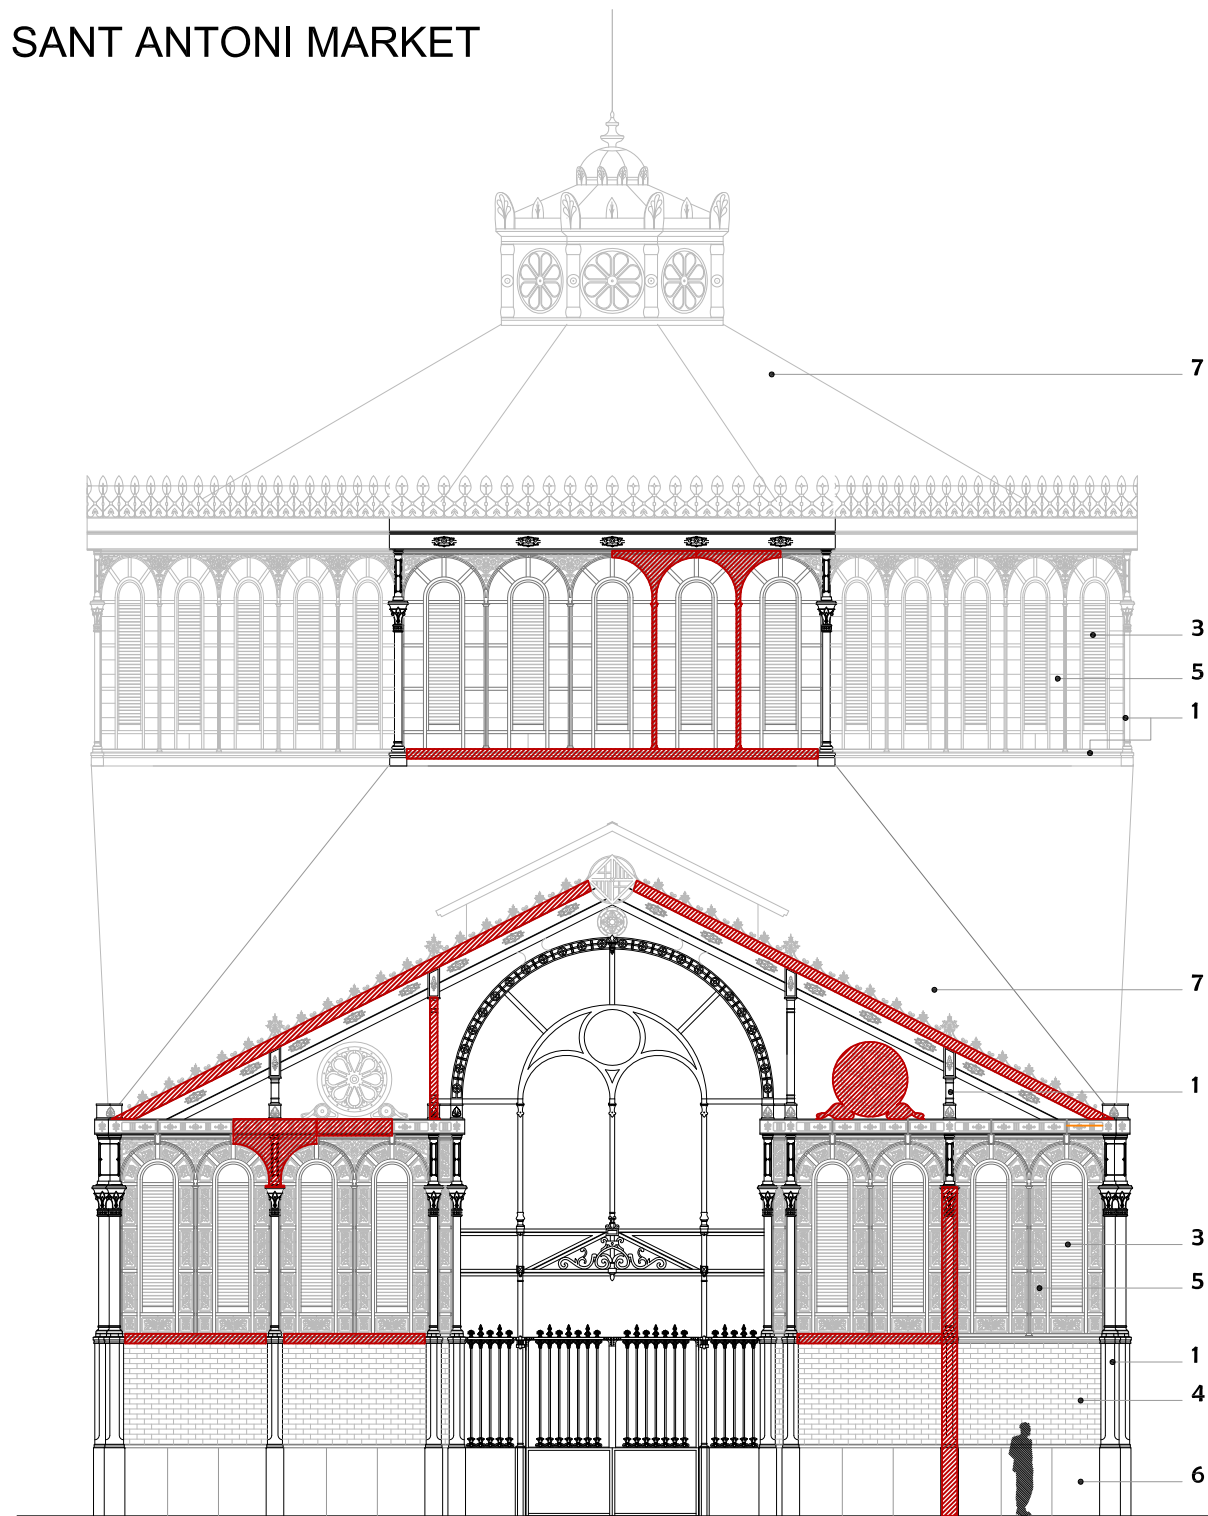
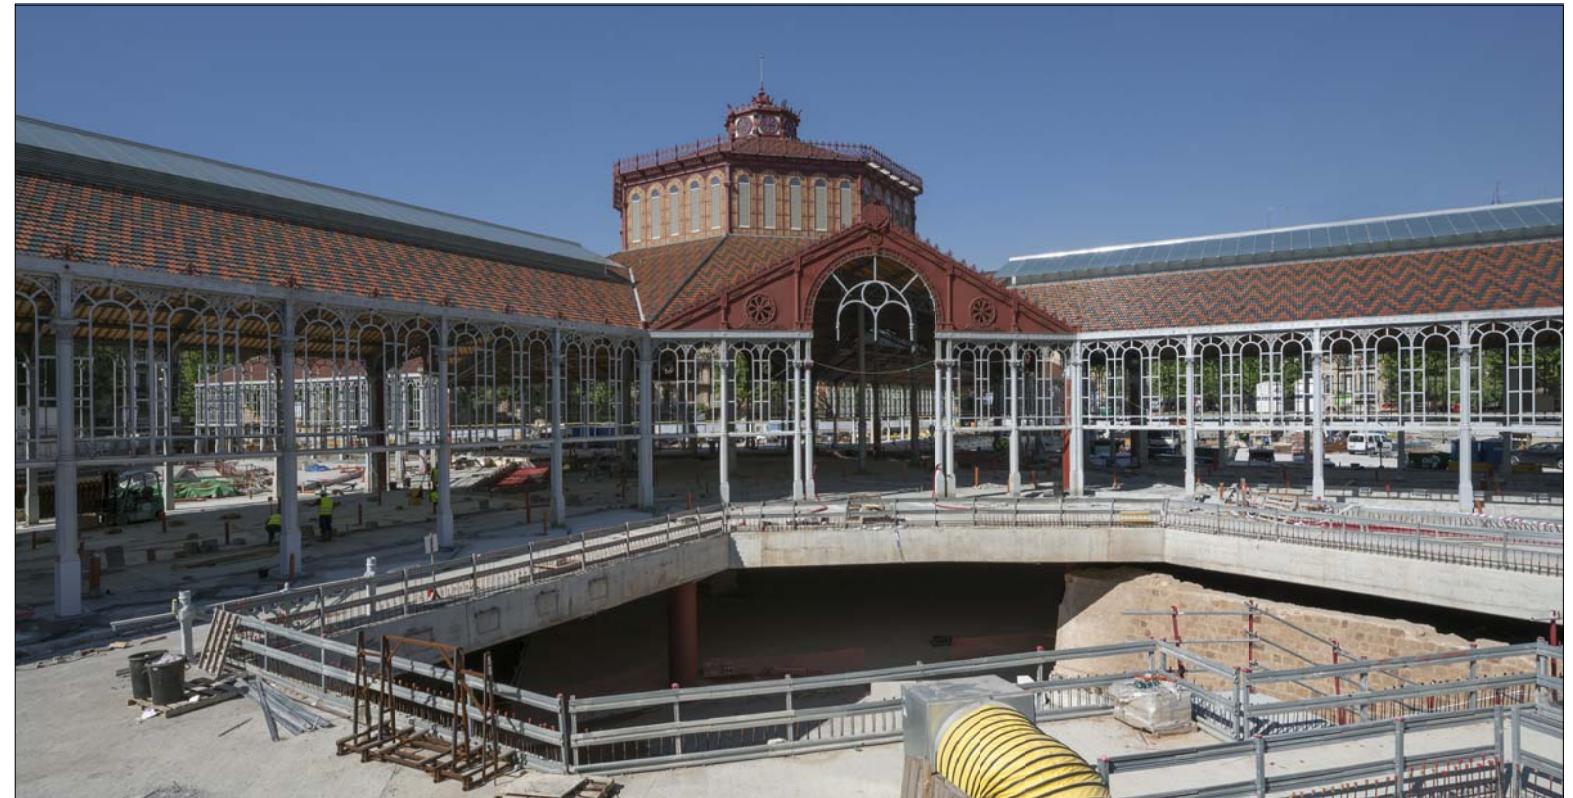
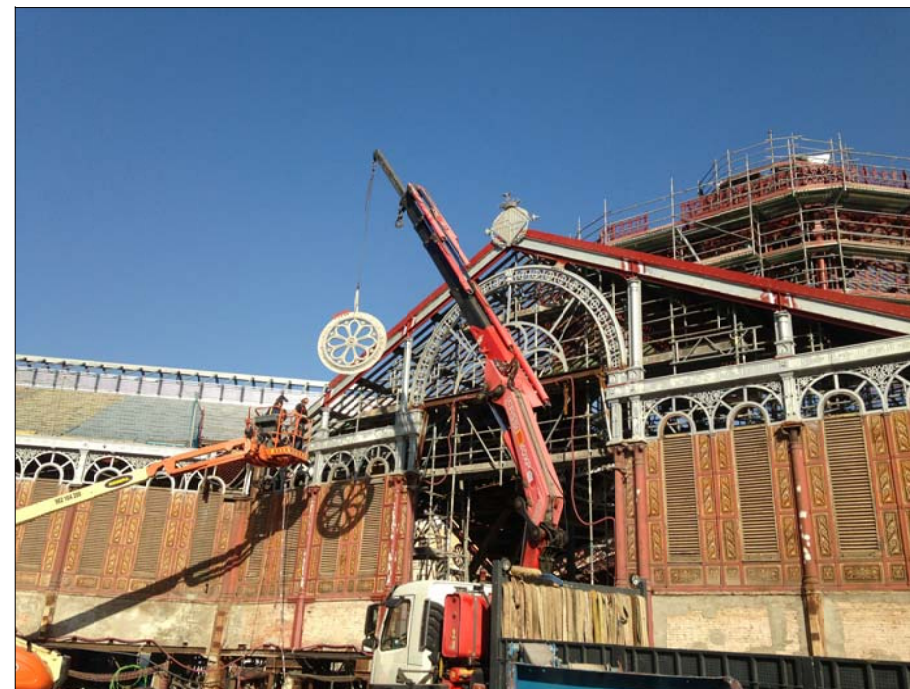
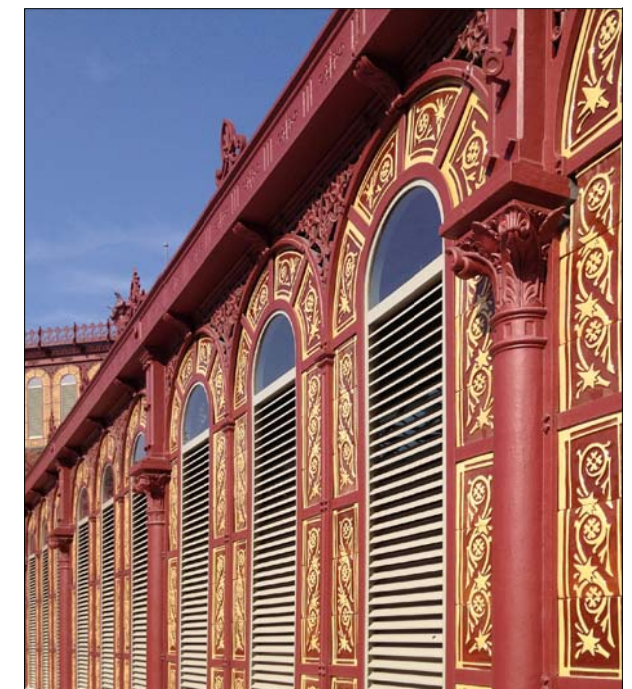
RESTORATION

Replaced elements

RESTORED ELEMENTS

1. Iron - Main structure
2. Enclosure - Glass slats
3. Enclosure - Metal slats
4. Brick
5. Ceramics
6. Stone
7. Tile
